Draft Translation 753

THERMOGRAPHY CONTROL OF HEAT INSULATION AND TIGHTNESS OF BUILDINGS

. Axen and B. Pettersson

UNITED STATES ARMY
CORPS OF ENGINEERS
COLD REGIONS RESEARCH AND ENGINEERING LABORATORY
HANOVER, NEW HAMPSHIRE, U.S.A.

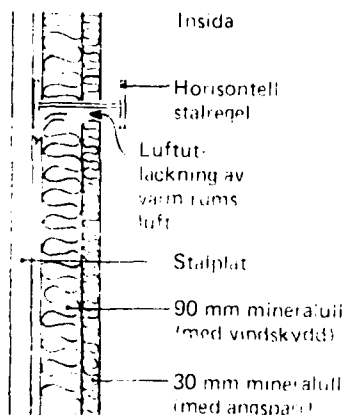
FIGURE 24: Insulation and tightness deficiencies causing air leakage through the construction. Various air flow directions through the same construction at different levels due to indoor positive pressure at the upper part of the wall and indoor negative pressure at the lower part.

- a) Thermogram from the inside of the wall on its upper part (approx. 15 m above floor level). Certain surface portions are warm due to warm room air leaking through the permeable construction.
(Text of the left hand figure: Inside: Horizontal steel bolt; Outward leakage of warm air from the room; Steel siding; 90 mm mineral wool (with wind protection); 30 mm mineral wool (with vapor barrier))

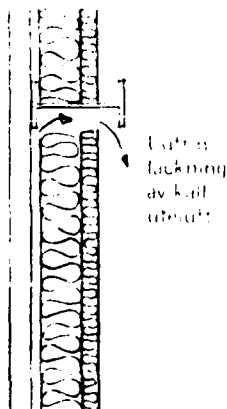
- b) Thermogram from the lower part of the wall (approx. 5 m above the floor) at the same vertical line as a). Here, certain surfaces are cold due to leakage of cold outdoor air through the permeable construction.
(Text at left-hand picture: Inward leakage of cold outdoor air.)

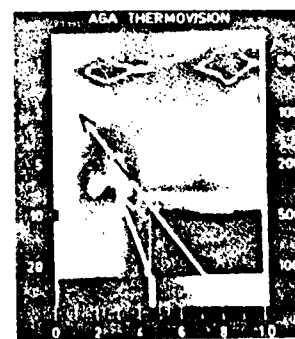
- c) Type thermogram of surface portion at a ceiling angle for stud wall No. 1 with built-in deficiencies. Notice errors 6 and 7. There is an air leakage through an imperfect connection at the ceiling.

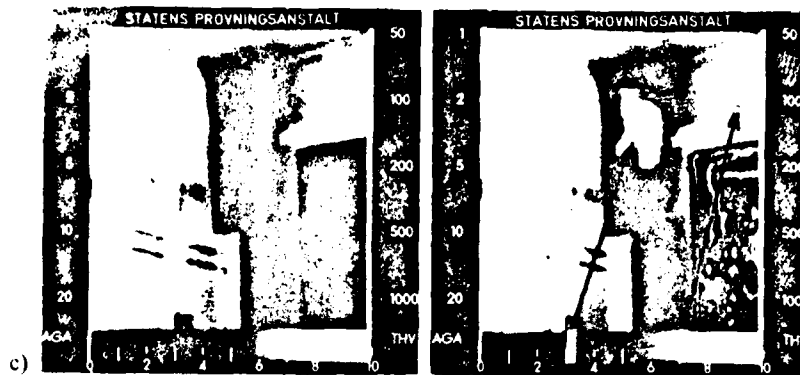
- c) Thermogram of surface portion of outside wall at ceiling angle. Cooled (dark) portion appear in the thermogram to the left of the window (grey tone image to the left, isotherm image to the right)
- $t_i - t_u = +21^\circ\text{C}$
 $p_i - p_u = -3 \text{ Pa}$
- $t_{\text{ref}} = +21^\circ\text{C}$
 $t = 2.5^\circ\text{C}$ (difference in surface temperature between "normal" wall temperature and cooled surface portion.

Conclusion: Probably, there is no insulation at the cooled surface portion in c).

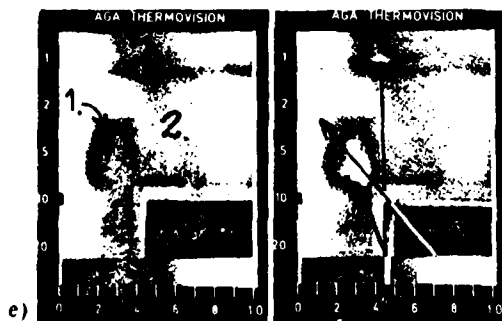
- e) Type thermogram for the same outside wall as in d) but with built-in deficiencies. The same measuring conditions as under d).

Error No. 2 corresponds to 50% insulation reduction in the wall.

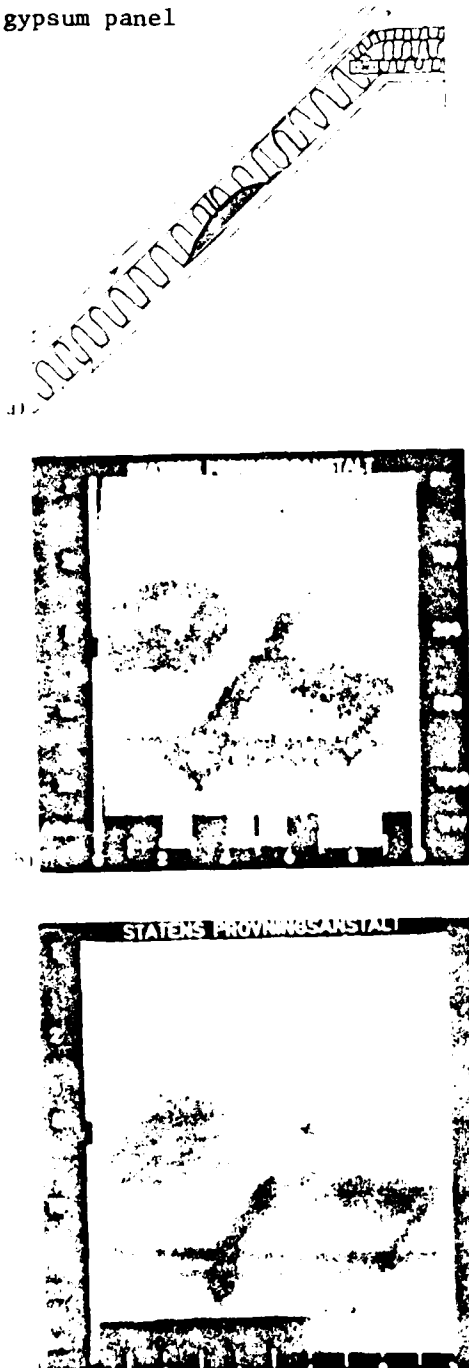
FIGURE 33: Color thermograms and black/white thermograms from the same surface portion.

- a) Construction of insulated sloping roof portion with deficient insulation.
- b) Color thermogram of sloping roof portion.
Upper temperature limit for color:
white + 21.0°C
yellow + 20.4°C
red + 19.7°C
purple + 19.0°C
light green + 18.4°C
dark green + 17.7°C
light blue + 17.0°C
dark blue + 16.3°C
- c) Thermogram (grey tone image) of the same surface portion as color thermogram in b). The cooled (dark) portions are related to deficient insulation.
- d) Isotherm image:
 $t_{ref} = + 20^{\circ}\text{C}$
 $\Delta I = - 1.2$ isotherm units
 $\Delta t = 1.5^{\circ}\text{C}$
 $v = 0$ m/s

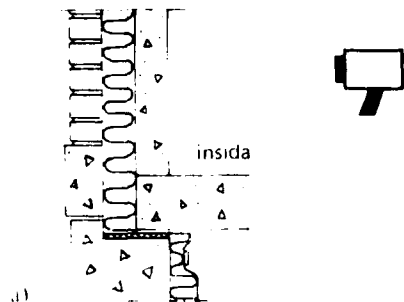
FIGURE 35: Investigation of heat insulation capacity of outside wall by heat flow measurement as well as thermography. (The results of the heat flow measurements corresponds well with those from thermography.)

- a) Construction of outside wall.
- b) The heat flow registers at points 1, 2, and 3 on the outside wall have been indicated.
k-value at each measuring point determined as being
 $k_1 = 0.45 \text{ W/m}^2 \text{ }^{\circ}\text{C}$
 $k_2 = 0.80 \text{ W/m}^2 \text{ }^{\circ}\text{C}$
 $k_3 = 0.30 \text{ W/m}^2 \text{ }^{\circ}\text{C}$
- c) Thermogram of partially cooled surface portion in center of wall. The cooling is probably related to insufficient filling with the insulation material. The insulation panels seem to be carelessly fitted to each other and do not touch the concrete.

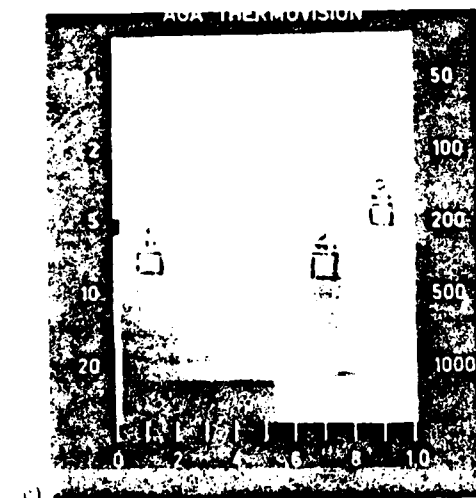
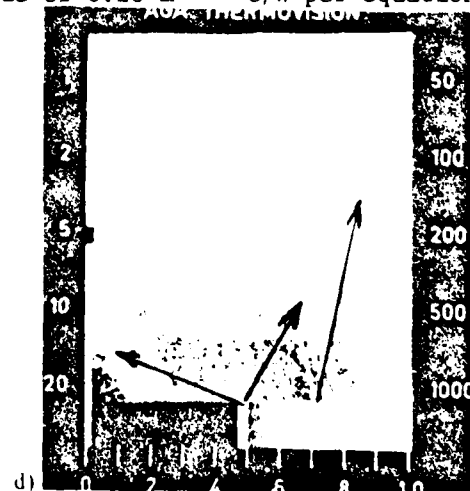
FIGURE 36: Investigation of heat insulation capacity of surface portion of roof, where a suspected deficiency has been verified - insufficient filling with insulation material in combination with unsatisfactory wind protection.

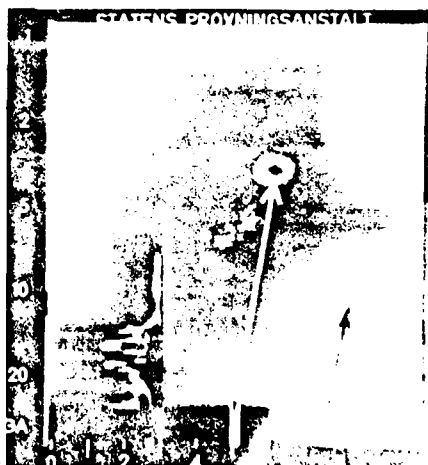
- Construction of insulated roof.
- Roof portion, opened from the inside. The insulation material is insufficiently filled against studs and gypsum panel. (Complicated construction.)
- Thermogram of surface portion of sloping roof - cooled area to the right of the window portion. The cooling is related to deficiencies according to b).
- $t_{\text{ref}} = + 19^{\circ}\text{C}$
 $\Delta I = - 2.6$ isotherm units
 $\Delta t = 3.5^{\circ}\text{C}$
 $v = 0$ m/s

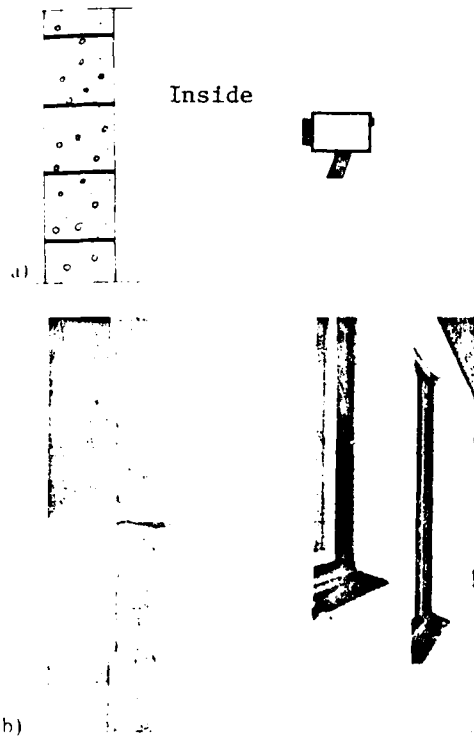
FIGURE 40: Investigation of heat insulation capacity of outside wall of light concrete where a suspected deficiency - cracks in the construction - was verified by means of visual inspection, smoke gas test, and air speed measurement.

- Construction of outside wall.
- Cracks in outside wall portion. The crack went through the entire thickness and caused direct air leakage into the residential space.
- Thermogram of partially cooled wall portion close to the window. There was air leakage both through cracks between joints of the light concrete blocks and through leaking joint between wall and window frame.
- $t_{ref} = + 22^\circ\text{C}$
 $\Delta I = - 1.1$ isotherm unit
 $\Delta t = 1.5^\circ\text{C}$
 $v = \text{approx. } 0.3 \text{ m/s (close to the wall at the crack)}$

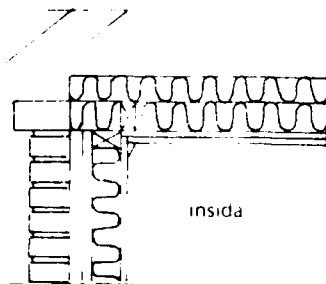
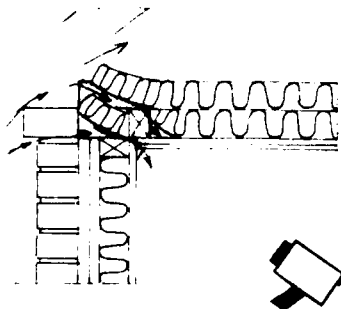
FIGURE 41: Deficiencies in insulation and tightness at the eaves due to unsatisfactory fitting of insulation material and unsatisfactory workmanship in the wind barrier.

b) Observed deficiency in the insulation and tightness performance.

c) Thermogram of surface portion under the eaves. Cooled area has characteristic "toothy" outline, indicating inward air leakage.

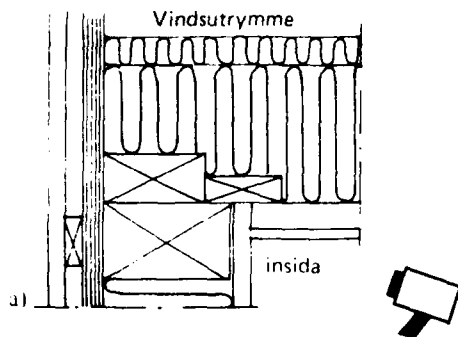
FIGURE 42: Deficiency in insulation and tightness at eaves due to insufficient insulation material filling and badly executed wind barrier.

- a) Construction at eaves
- b) Observed error in the insulation executions (No PE foil installed)

- c) Thermogram of surface portion at the eaves. Cooled surface portions appear as well marked dark lines, indicating inward air leakage in the channels formed in the construction by the sheet screens.

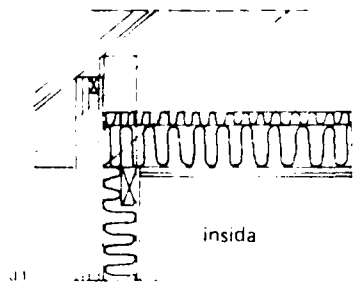
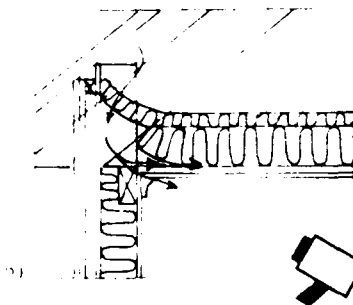
FIGURE 44: Deficiencies in insulation and tightness at the eaves due to insufficient insulataion material filling in the construction and bad execution of wind barrier.

- a) Construction of the truss connection.
- b) Erroneous insulation execution at eaves.
- c) Thermogram of surface portion at the roof angle. The area next to the cornice is cooled. The cooling due partially to inward air leakage, partially insufficient insulation material filling at the connection.

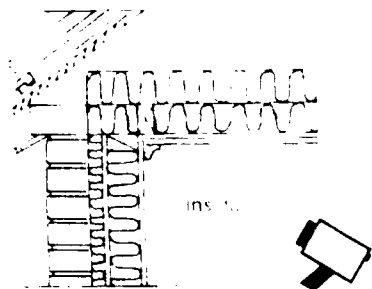
FIGURE 45: Deficiencies in insulation and tightness at the truss connection due to insufficient filling of insulation material in the construction and badly executed wind barrier.

- a) Construction of the truss connection.
- b) Inward air leakage at the eaves. Bad insulation filling around the rafters. No continuity of the wind barrier at the truss proper.
- c) Thermogram of surface portion at the roof angle. Cooled area in the ceiling next to the roof angle is due to bad insulation around the truss at the edge of the rafters. The cooling is also propagated in the channels formed by the sheet screen construction. Certain inward air leakage into the residential area.
- d) $t_{ref} = 19^{\circ}\text{C}$
 $\Delta I = - 5.2$ isotherm units
 $\Delta t = 8.0^{\circ}\text{C}$

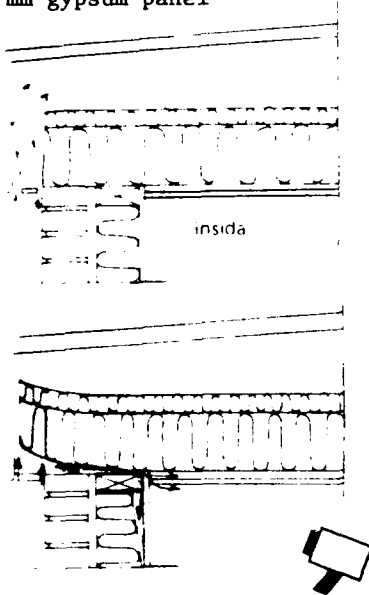
FIGURE 47: Deficiency in insulation and tightness at the eaves due to unsatisfactory fitting of insulation material and badly executed wind barrier.

- a) Construction at the eaves.
- b) Erroneous insulation execution in the wall and at the eaves.
- c) Thermogram of surface portion at the roof angle, showing a cooled area of irregular shape. A narrow, cooled area extends downward into the wall. The cooling caused partially by inward air leakage, partially by badly executed insulation in the wall and at the eaves.

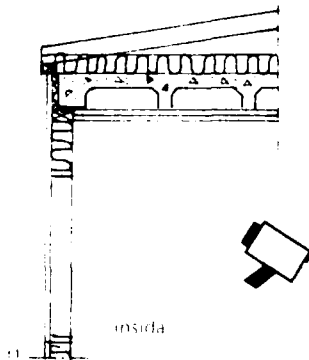
FIGURE 48: Deficiency in insulation and tightness in the truss of concrete components due to cold bridge effect and certain inward air leakage in the construction and into the residential space.

c) Thermogram of surface portion at the roof angle. A 15 - 20 cm wide strip from the roof angle forms a cooled area along the outside wall. Certain inward air leakage in the sheet screen construction, as well as lesser inward air leakage into the residential space.

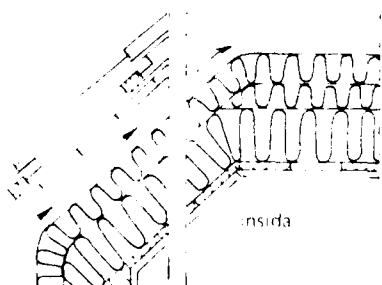
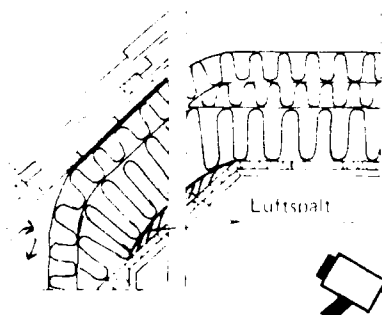
FIGURE 49: Deficiency in insulation and tightness at sloping roof due to unsatisfactory fitting and attachment of insulation material towards the warm side as well as inward air leakage in the construction.

- Construction of insulated outer roof (Below right hand part: Inside)
- Erroneous insulation execution (Below right hand part of figure: Air space)
- Thermogram of surface portion at the sloping roof. Inward air leakage in the construction, whereby cold air is diffused in the empty spaces between insulation material and sheet screen.
- $t_{ref} = + 19^\circ$
 $\Delta I = - 2.6$ isotherm units
 $\Delta t = 4.0^\circ C$
 $v = 0$ m/s

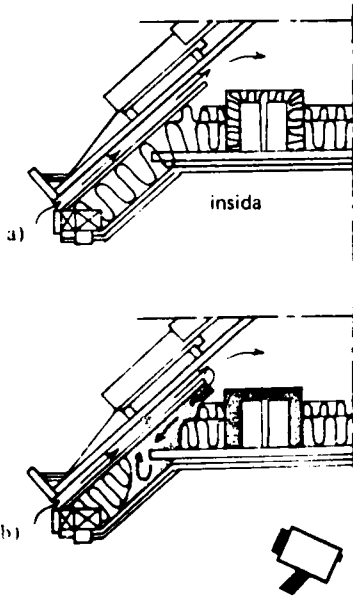
FIGURE 50: Deficiency in insulation and tightness at sloping roof, due to insufficient filling of insulation material at the connection between sloping roof and collar beam.

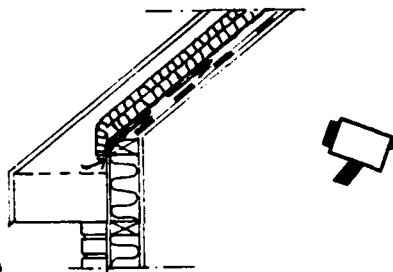
FIGURE 52: Deficiency in insulation and tightness due to insufficient filling of insulation material, in combination with inward air leakage in the construction.

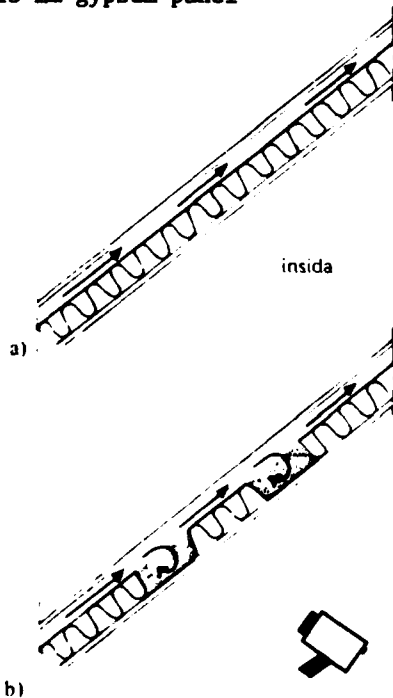
FIGURE 53: Deficiencies in insulation execution, partial elimination of insulation material.

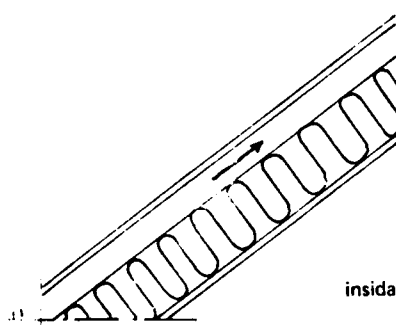
b) Deficient insulation execution. The thickness of the insulation is reduced to approx. 50% of original thickness.

c) Thermogram of cooled surface portion in the roof. The cooled area is well marked with even outlines. The cooling is caused by approx. 50% insulation material is missing in the spaces between the beams according to b).

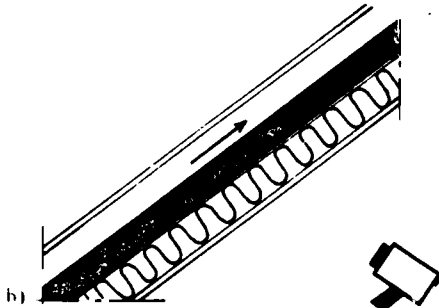
FIGURE 54: Deficiency in insulation and tightness due to bad fitting of insulation material against studs and badly executed wind barrier.

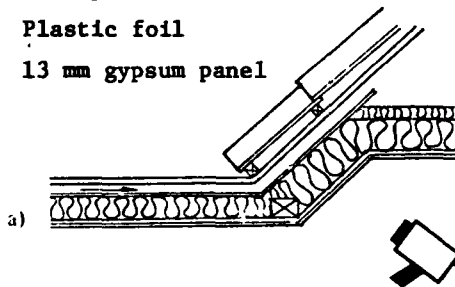
FIGURE 55: Deficiency in insulation and tightness due to bad filling of insulation material against the construction components, in combination with inward air leakage.

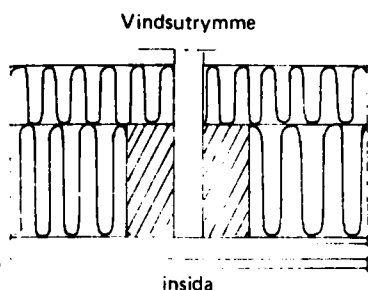
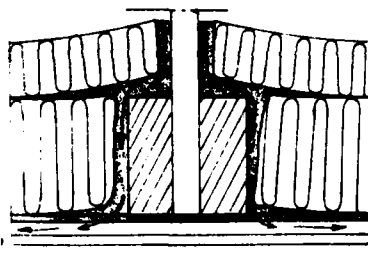
- a) Construction of roof beam tier. In order for insulation to function well, careful fitting of the mineral wool against the truss is required. (Above figure: Attic space. Below figure: Inside)
- b) Unsatisfactory filling of insulation material. Outside air propagates in empty spaces and channels formed in sheet screen construction. The plastic foil should be placed in the layer between the sheet screen and the insulation.
- c) Thermogram of surface portion at roof and roof angle. Cooled area in the roof appears as dark parallel lines starting from the rafters.

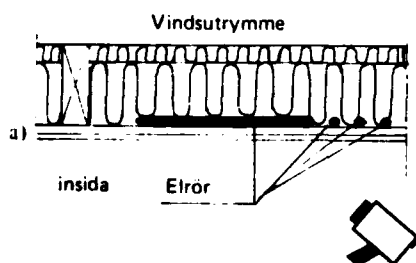
b) Deficient insulation around electrical wiring conduit.

c) Thermogram of surface portion in roof, showing a relatively obviously cooled portion. The cooling caused by unsatisfactory execution of insulation around electrical wiring conduits. Cooled areas propagate from the rafters.

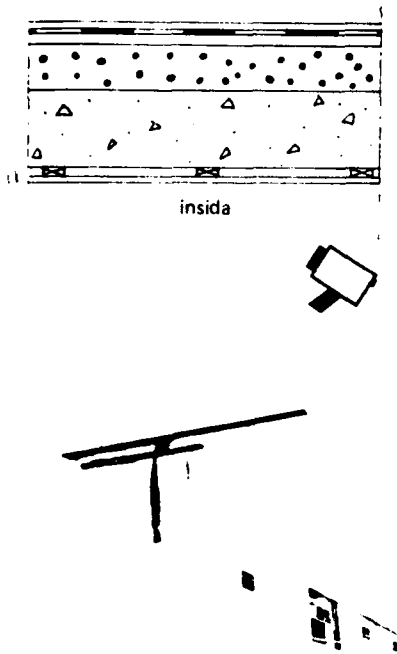
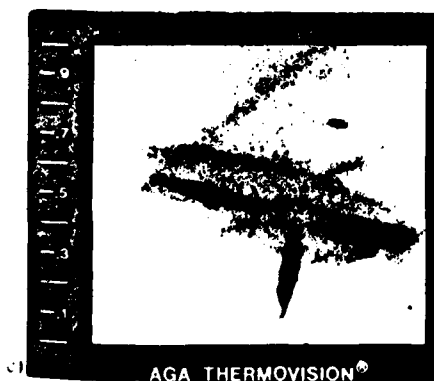
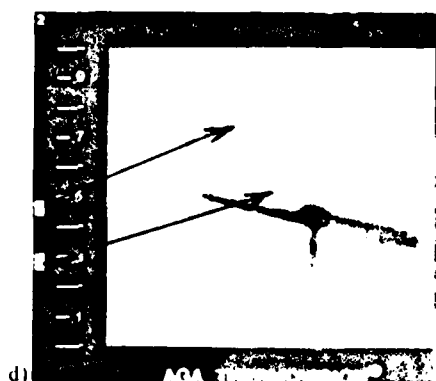
FIGURE 58: Deficiency in insulation and tightness at the connection of the intermediate beam tier to upright member wall, due to insufficient filling of insulation material and badly executed wind protection.

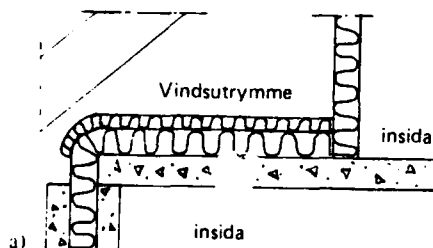
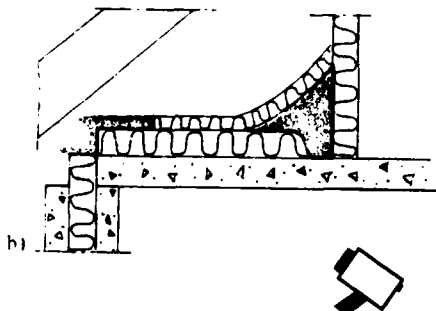
- a) Construction of intermediate beam tier of concrete with additional insulation of mineral wool (In figure, clockwise: Attic space / Inside / Inside).
- b) Deficiency in insulation execution.
- c) Thermogram of surface portion in the roof and at the roof angle. The cooling in the roof caused by insufficient filling of insulation material at the beam tier, both where the upper floor upright member wall connects to the beam and at the eaves.

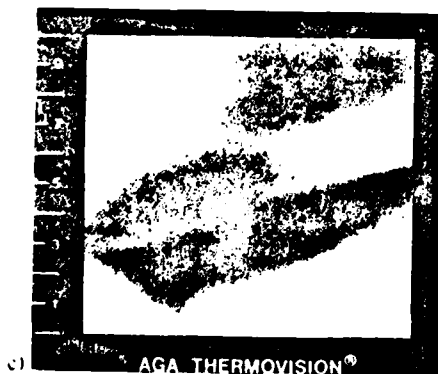
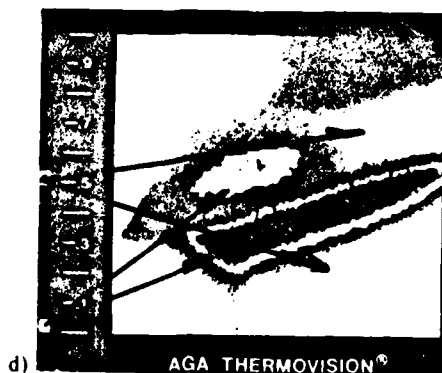
FIGURE 59: Deficiency in insulation and tightness in intermediate beam tier of wood, due to insufficient filling of insulation material at connection to upright member wall.

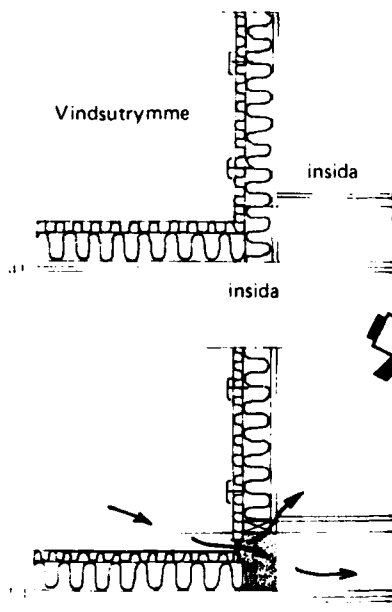
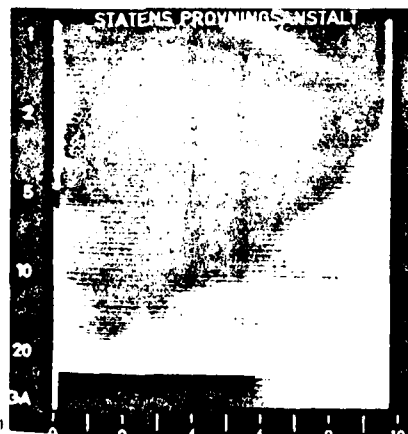
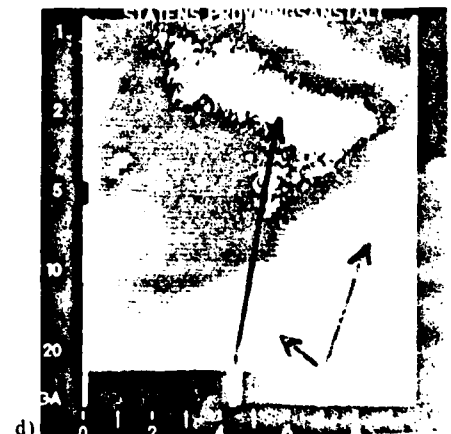
FIGURE 60: Deficiency - crack formation - in insulation and tightness due to insufficient filling of insulation material in the wall, in combination with inward air leakage in joint due to unsatisfactory connection between beam tier and outside walls.

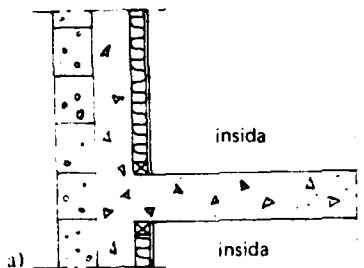
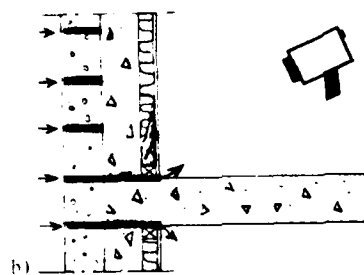
b) Inward air leakage at connection of intermediate beam tier with gable wall.

c) Thermogram of surface portion at floor angle (upper floor). Cooled areas have relatively uneven outlines. Cooling caused by inward air leakage due to untight connection of the beam tier.

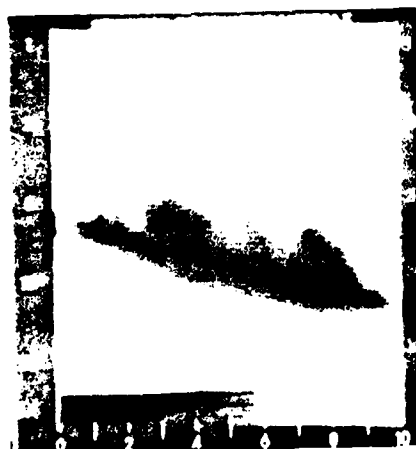
FIGURE 61: Deficiency in insulation and tightness due to insufficient filling of insulation material in the beam tier at the connection to outside wall.

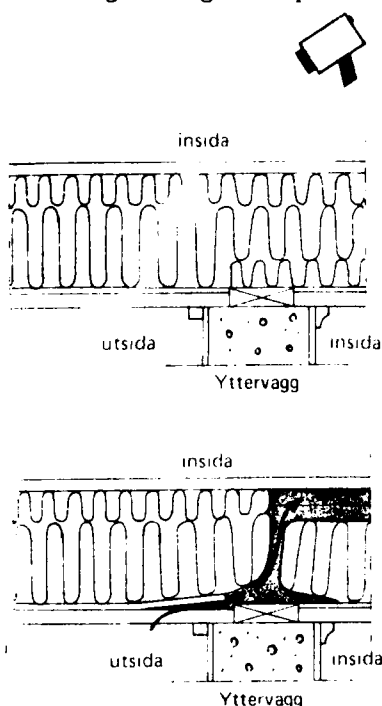
FIGURE 62: Deficiency in insulation and tightness due to bad sealing layer at the connection of the beam tier with upright member wall.

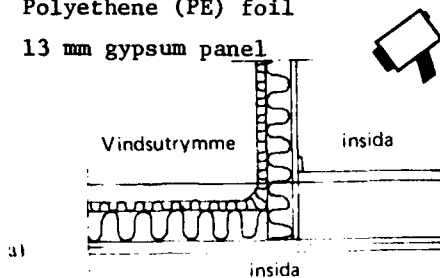
- Construction of intermediate beam tier and connecting upright member wall (Clockwise in figure: Attic space / Inside / Inside)
- Wall portion (partially opened wall) with kickboard removed. Inside wall covering ends closely above the floor.
- Thermogram of cooled surface portion at the floor angle. Cooling caused by badly executed sealing at the connection between upright member wall and beam tier, resulting in strong inward air leakage.

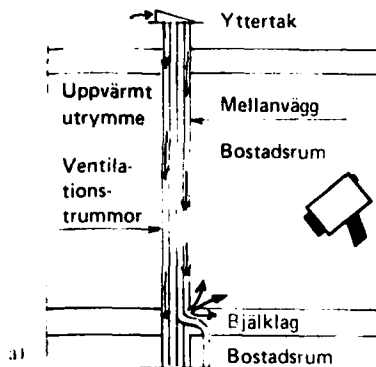
COMPARISON THERMIGRAM - HORIZONTAL INTERMEDIATE BEAM TIER

- Location of insulated ventilation ducts according to sketch.
- Deficient insulation execution around the ventilation ducts with significant air space between the ducts.
- Thermogram of cooled surface portion at floor angle where inside wall connects to intermediate beam tier. (Heated space behind the construction components.) Cooling caused by inward air leakage of cold air between the ventilation ducts. Air spreads in the beam tier, predominately to portions where the ventilation duct connects to the beam tier, and leaks into the room.

FIGURE 64: Deficiency in insulation and tightness - bad fitting and joining of insulation material against construction components.

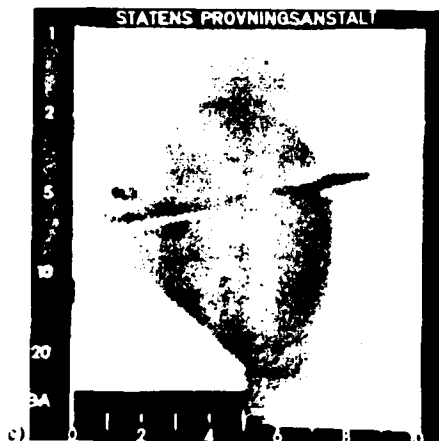
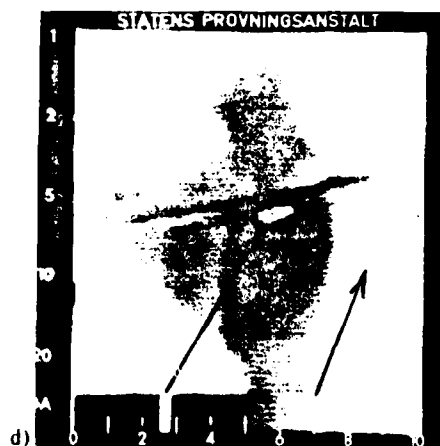
COMPARISON THERMOGRAM - FLOOR JOIST TIER OF CONCRETE AT CRAWL SPACE
(connection to outside wall of wood).

b) Deficient insulation. The mineral wool does not touch the rafter. Air leakage into the construction.

FIGURE 65: Deficiency in insulation and tightness due to bad sealing of joists.

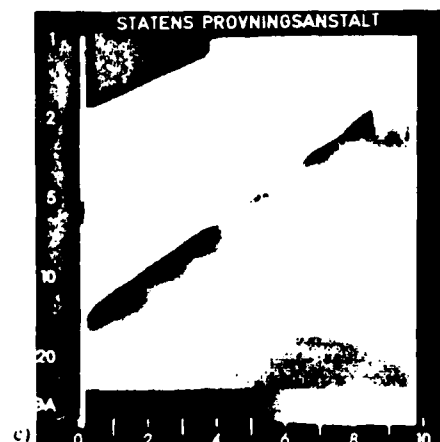
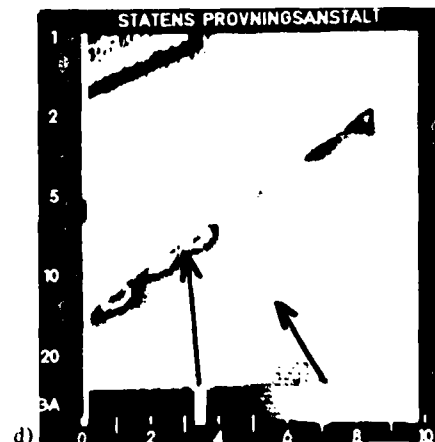
COMPARISON THERMOGRAM - FLOOR JOIST TIER OF CONCRETE, SLAB CONSTRUCTION
(connection with outside wall)

b) Deficient sealing execution at joist.

c) Thermogram of surface portion at floor angle below window portion with electrical heating panels. Uneven cooling along the kickboard. Cooling due to inward air leakage through badly sealed connection at joist as in b).

FIGURE 66: Deficiencies in insulation and tightness due to bad edge insulation.

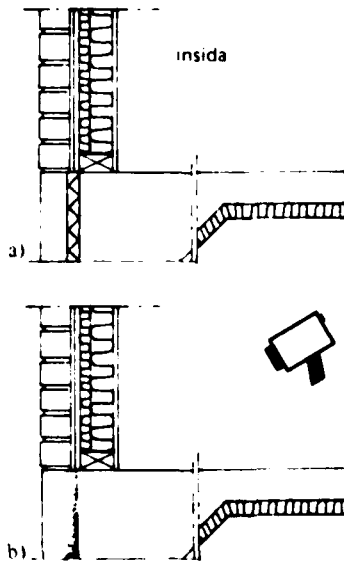
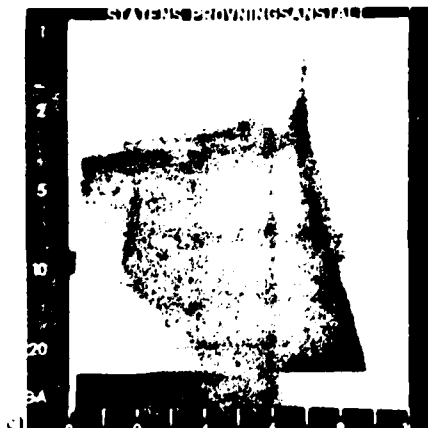
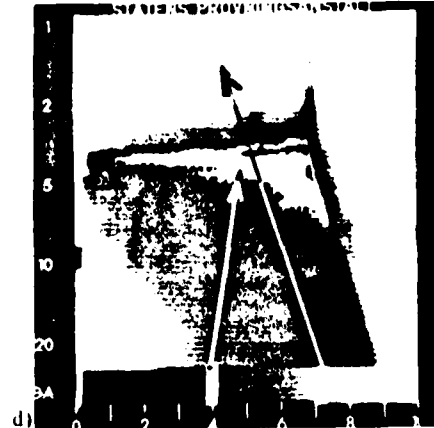
COMPARISON THERMOGRAM - JOIST TIER OF WOOD AT CRAWL SPACE (connection with outside wall).

c) Thermogram of cooled floor portion next to outside wall. Cooling appeared some 0.5 m from outside wall, caused by absence of insulation of the edge joist.

FIGURE 67: Deficiency in insulation and tightness due to faulty assembly and incomplete filling with insulation material in the edge portion of the joist tier.

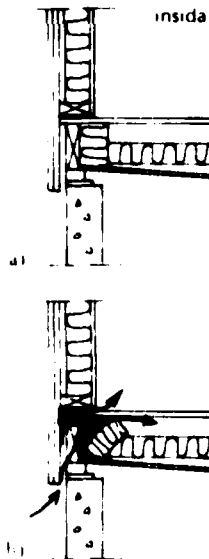
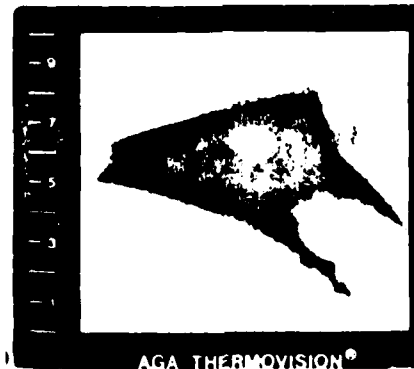
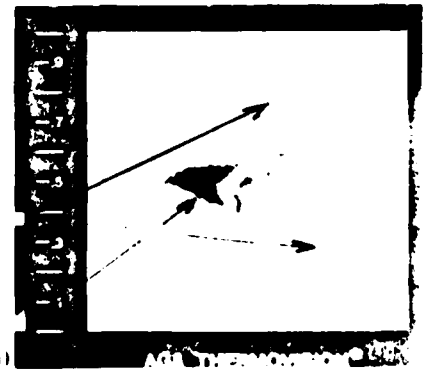
COMPARISON THERMOGRAM - JOIST TIER OF WOOD AT CRAWL SPACE (connection with outside wall)

- Construction of joist tier (In figure: Inside)
- Faulty insulation in joist tier where insulation material does not fill completely along the edge of the joist tier.
- Thermogram of cooled surface portion at the floor angle (corner of outside walls). Cooling caused by inward air leakage both in the joist tier and into the residential area.
- $t_{\text{ref}} = + 20^{\circ}\text{C}$
 $\Delta I = - 1.8$ isotherm units
 $\Delta t = 3.0^{\circ}\text{C}$
 $v = 1.0 - 1.5$ m/s

FIGURE 68: Deficiencies in insulation and tightness due to incomplete filling of insulation material, resulting in inward air leakage into the construction,

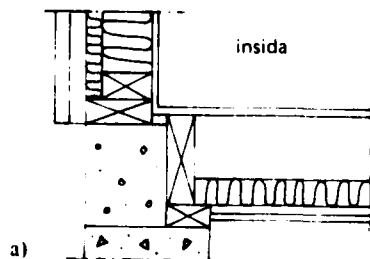
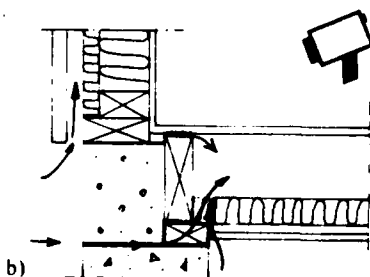
COMPARISON THERMOGRAM - JOIST TIER OF WOOD AT CRAWL SPACE (connection with load carrying inside walls).

c) Thermogram of surface portion at the floor. Cooled zone on the floor. Cooling caused by air leakage into the joist tier.

FIGURE 69: Deficiencies of insulation and tightness due to leakage in the connection between joist tier and inside wall.

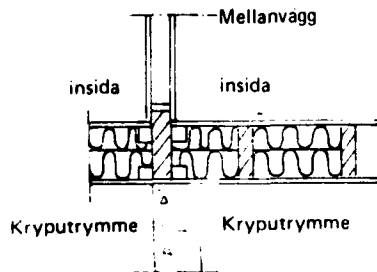
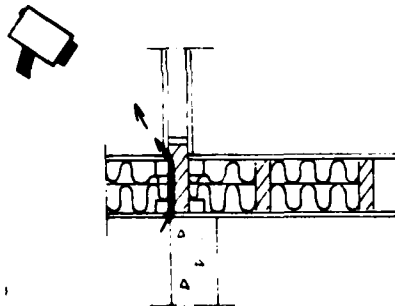
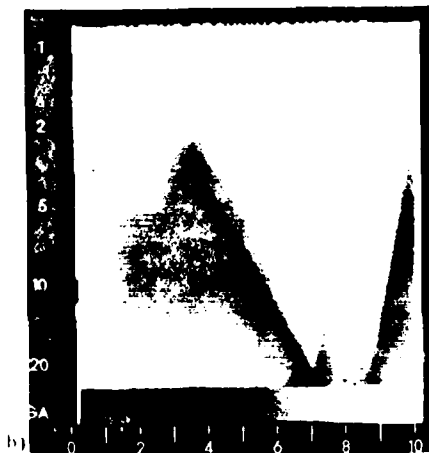
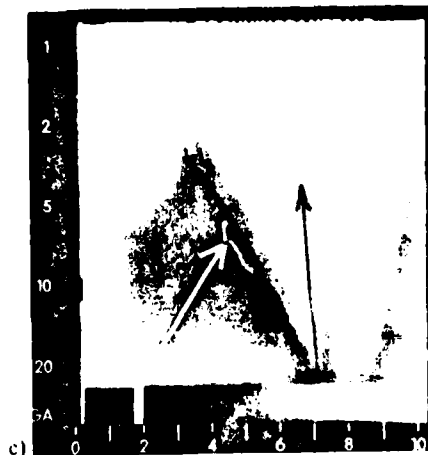
COMPARISON THERMOGRAM - OUTSIDE WALL OF WOOD WITH EXTERIOR BRICK SIDING

a) Construction of joist tier (prefabricated components) and the inside wall connection. Route of incoming air has been marked.

b) Thermogram of cooled surface portion where inside wall connects with joist tier. Cooling caused by inward air leakage through open joint between joist tier components.

FIGURE 70: Deficiency in insulation and tightness due to bad filling with insulation material around electrical wiring. Polyethene (PE) foil torn.

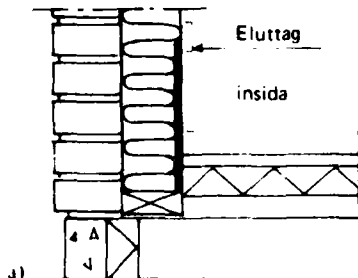
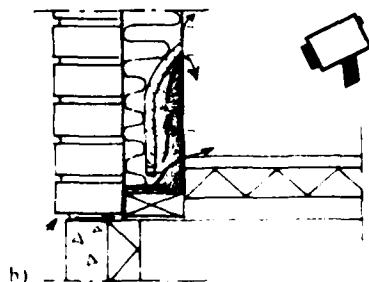
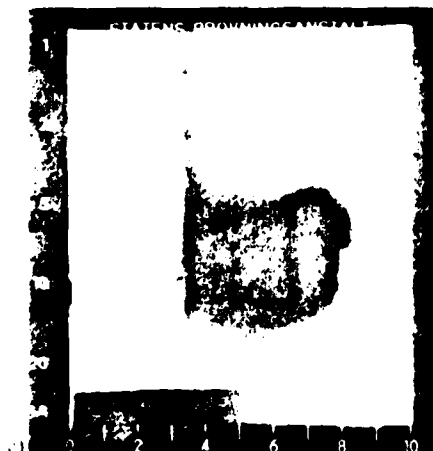
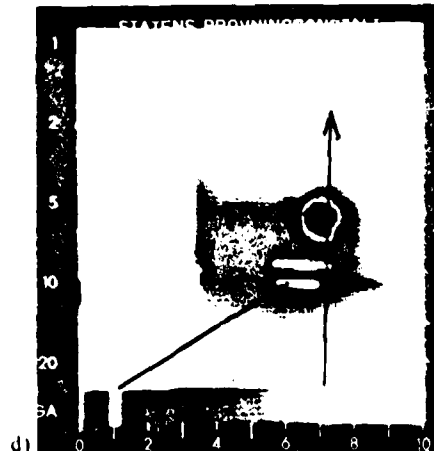
COMPARISON THERMOGRAM - OUTSIDE WALL OF WOOD WITH EXTERIOR WOOD SIDING

- a) Construction of outside wall and joist tier in conjunction with electrical outlet (In figure: Electrical outlet ... inside)
- b) Badly executed insulation around electrical wiring in the wall.
- c) Thermogram of surface portion at the floor angle. The area around the electrical outlet is considerably cooled partly due to bad insulation around the electrical wiring in the wall and partly due to inward air leakage.

FIGURE 71: Deficiency in insulation and tightness due partly to insufficient filling of insulation material in the wall.

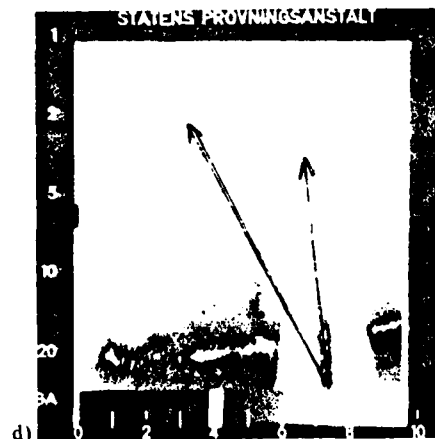
COMPARISON THERMOGRAM - OUTSIDE WALL OF WOOD WITH EXTERIOR WOOD SIDING

b) Opened wall portion corresponding to surface portions in thermograms c) and d). Fully satisfactory insulation filling. The joist and parts of the vertical studs are moist (free water). (In figure: Moisture)

The wall surface has a slightly uneven temperature distribution. The area next to the floor is unevenly cooled due to moisture in the construction. The surface portion corresponds to the connection between the outside wall and the intermediate beam tier.

FIGURE 73: Deficiency in insulation and tightness due to incomplete filling of insulation material towards the warm side (air spaces).

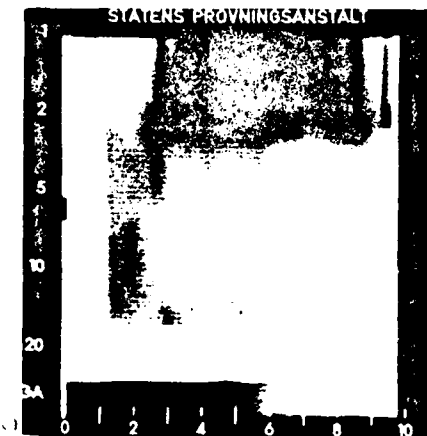
COMPARISON THERMOGRAM - OUTSIDE WALL CORNER OF WOOD

FIGURE 74: Deficiency in insulation and tightness due to absence of insulation material in a corner portion and to badly executed wind barrier.

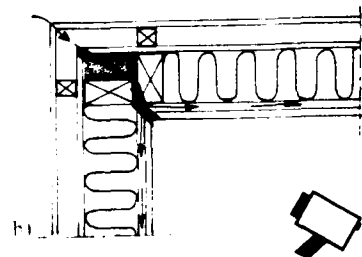
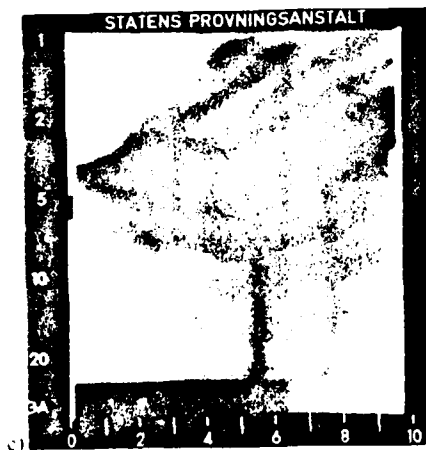
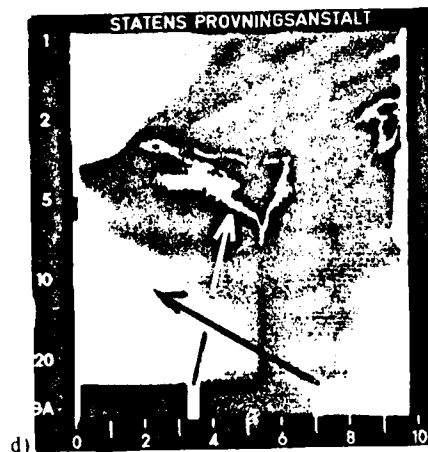
COMPARISON THERMOGRAM - OUTSIDE WALL OF WOOD WITH EXTERIOR WOOD SIDING

b) Deficiency in tightness in corner

c) Thermogram of surface portion at outside wall corner. Wall and ceiling surfaces are cooled. Cooling caused by inward air leakage in channels formed in the sheet screen construction.

FIGURE 75: Deficiency in insulation and tightness due to incomplete filling with insulation material in the spaces between studs for the height of an entire apartment level.

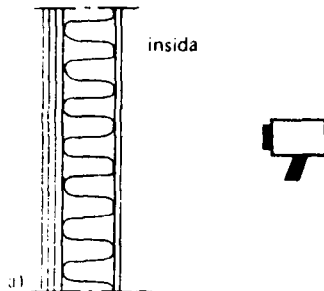
a) Construction of outside wall (In figure: Inside)

b) Opened wall portion with incomplete filling of insulation material. In the spaces between the studs, the filling is uneven for the height of an entire floor level. (In figure: Beam tier / Outside wall).

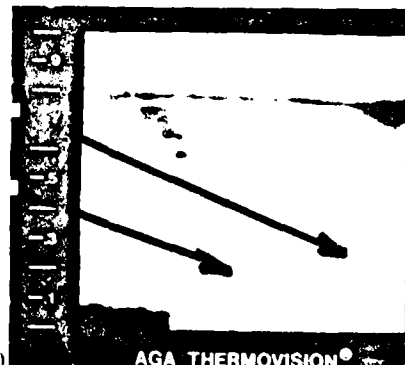
COMPARISON THERMOGRAM - OUTSIDE WALL OF WOOD WITH CONNECTION TO WOODEN TRUSS

FIGURE 76: Deficiencies in insulation and tightness due to incomplete filling of insulation material at the roof connection.

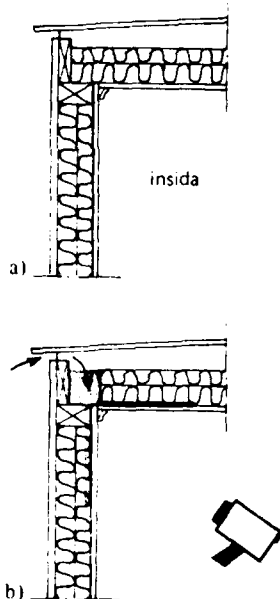
COMPARISON THERMOGRAM - UPRIGHT MEMBER WALL OF WOOD AT CONNECTION WITH INSULATED SLOPING ROOF PORTION

FIGURE 77: Deficiency in insulation and tightness due to incomplete filling with insulation material and unsatisfactory sealing layer.

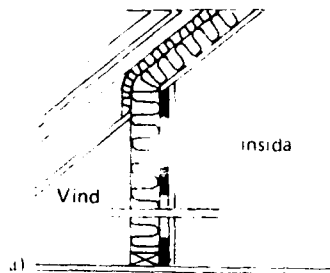
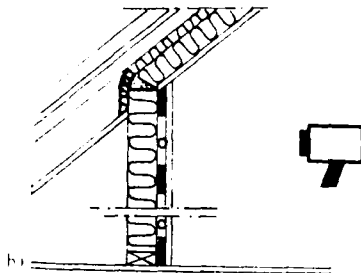
- a) Construction of wall at oriel (In figure: Attic (l) / Inside (r))
- b) Deficiency in insulation and tightness. Air leaks into the construction at studs and in corner areas and is propagated through channels between the panel boards.
- c) Thermogram of surface portion at oriel. The vertical part of the outside wall is unevenly cooled by outdoor air spreading in channels formed in the sheet screen construction.

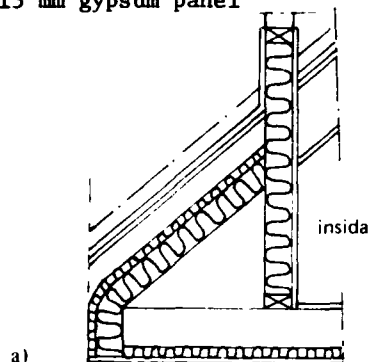
a) Construction of upright member wall at outside wall (In figure: inside)

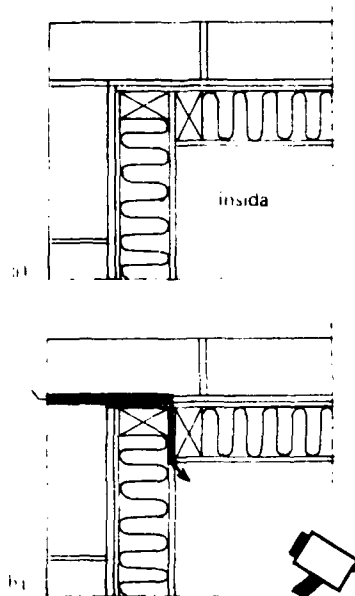
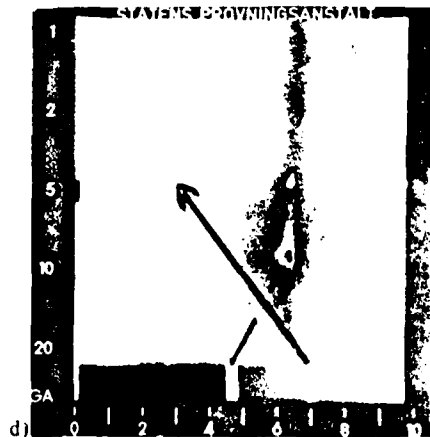
COMPARISON THERMOGRAM - OUTSIDE WALL OF LIGHT CONCRETE

FIGURE 80: Deficiency in insulation and tightness function due to crack formations at joints both between light concrete blocks and at wall corners (connection outside wall - inside wall).

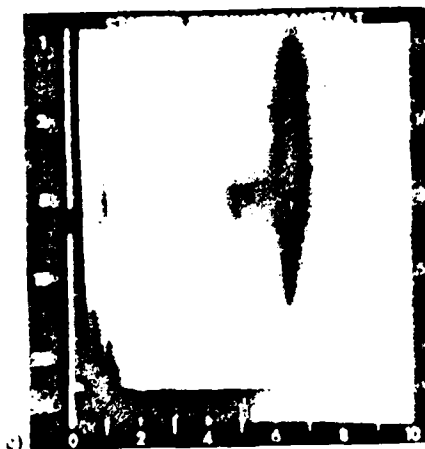
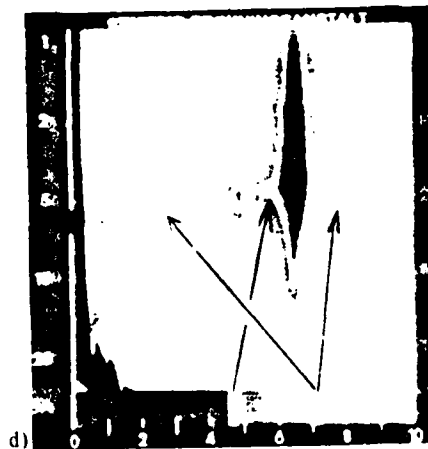
COMPARISON THERMOGRAM - OUTSIDE WALL OF LIGHT CONCRETE COMPONENTS

FIGURE 81: Deficiency in tightness due to penetrating crack in joint between the light concrete components.

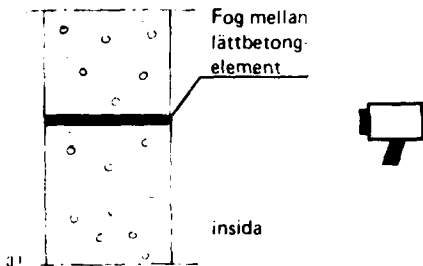
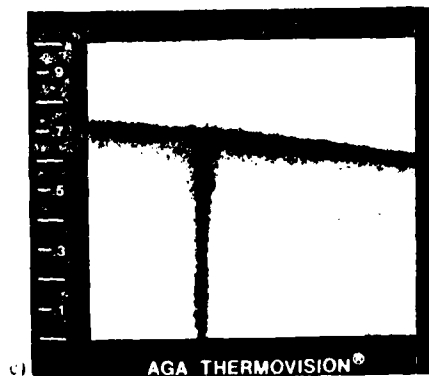
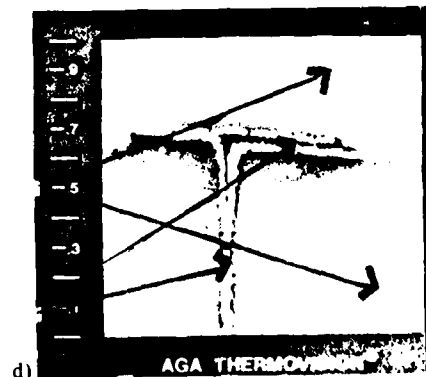
COMPARISON THERMOGRAM - CONNECTION BETWEEN OUTSIDE WALLS OF CONCRETE AND LIGHT CONCRETE

FIGURE 82: Deficiency in tightness function of outside wall, corner portion, due to crack formation in the joint between walls of concrete and light concrete.

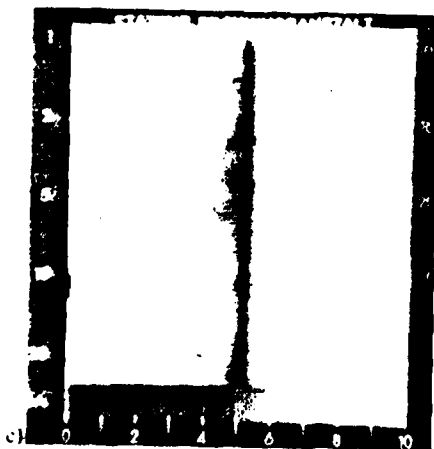
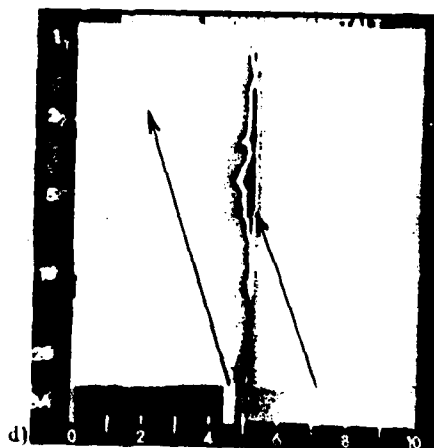
COMPARISON THERMOGRAM - OUTSIDE WALL OF CONCRETE HOLLOW BLOCKS WITH INSULATION.

FIGURE 83: Deficiency in insulation and tightness functions of outside wall at ventilation duct due to incomplete filling with insulation material in the wall (particularly against studs).

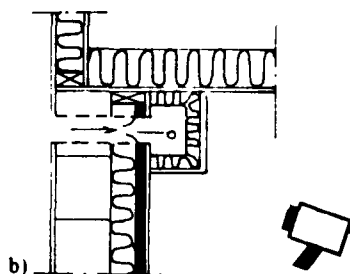
Outside wall, from outside:
200 mm concrete hollow blocks
70 mm mineral wool
13 mm gypsum panel

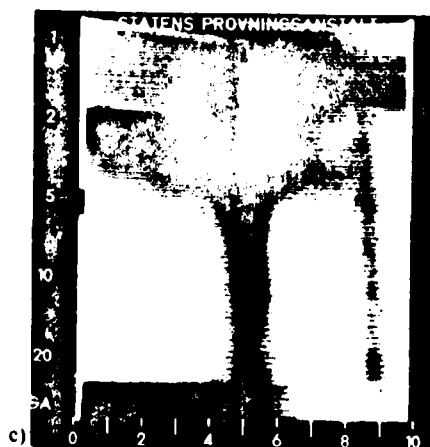
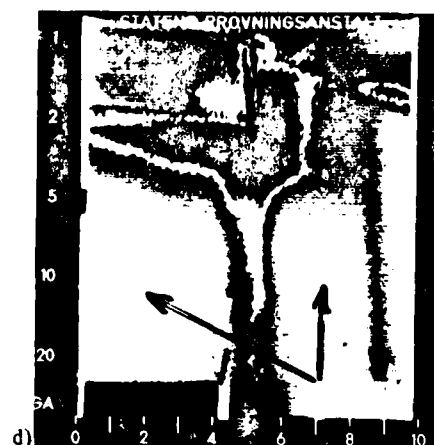
COMPARISON THERMOGRAM - OUTSIDE WALL OF CONCRETE WITH MINERAL WOOL INSULATION
AND EXTERIOR BRICK FACING.

FIGURE 84: Deficient insulation function due to incomplete contact of insulation material (B quality) with the concrete.

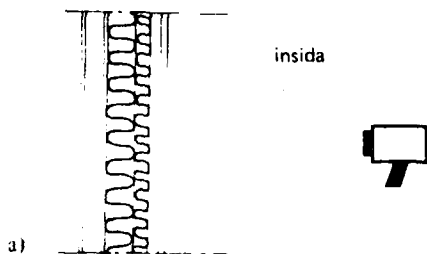
FIGURE 85: Deficiencies in insulation and tightness due to insufficient filling of insulation material in combination with bad sealing layer.

- a) Construction of outside wall with interior and exterior metal siding.
- b) Inside metal surface. Portions of the surface painted with matte, grey color (one coat).
- c) Thermogram of portion of outside wall. Certain cooled areas appear. The cooling is caused by convective air movements in the construction. Certain joints between the mineral wool panels appear as dark, vertical lines.

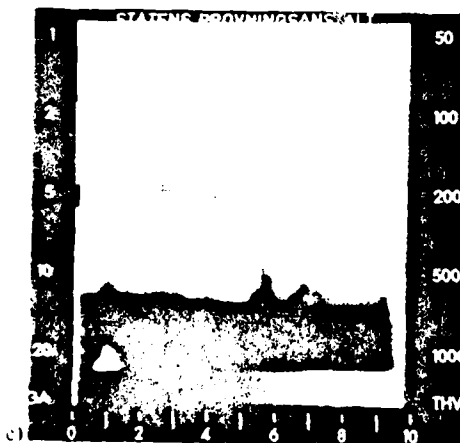
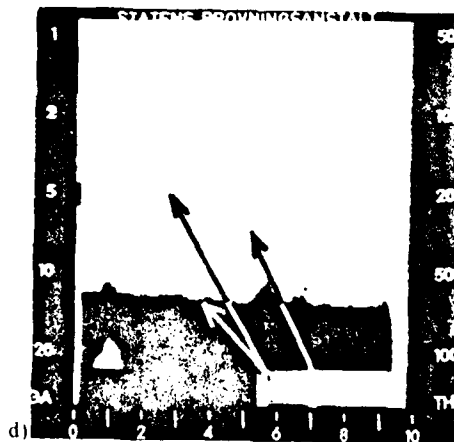
COMPARISON THERMOGRAM - INDUSTRIAL BUILDINGS - OUTSIDE WALLS
WITH STEEL PROFILES (interior and exterior metal siding)

FIGURE 86: Deficiencies in insulation and tightness due to totally or partially eliminated insulation material in certain portions, locally in the structure.

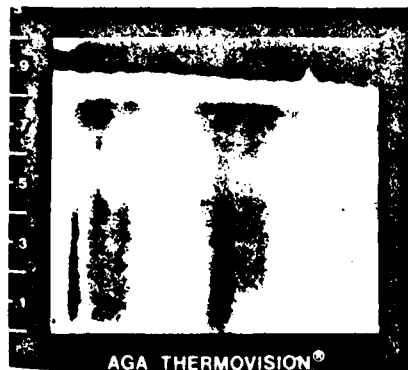
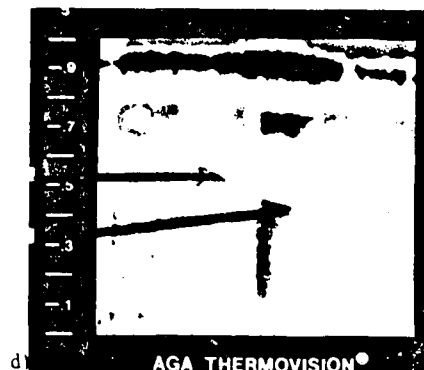
- a) Construction of outside wall with interior and exterior metal siding. (To the right in picture: Inside)
- b) Insulation missing for the entire thickness of some parts of the wall. (To the right in picture: Portion where insulation is totally absent).
- c) Thermogram of cooled surface portion in the middle of wall. The defect is related to total absence of insulation material in certain portions of the wall.
- d) $t_{ref} = + 11^{\circ}\text{C}$
 $\Delta I = - 1.0$ isotherm unit
 $\Delta t = 2.0^{\circ}\text{C}$
 $v = 0$ m/s

COMPARISON THERMOGRAM - INDUSTRIAL BUILDINGS - OUTSIDE WALLS
WITH STEEL PROFILES (interior and exterior metal siding)

FIGURE 87: Deficiency in insulation and tightness due to leaking connection
between outside wall and concrete foundation.

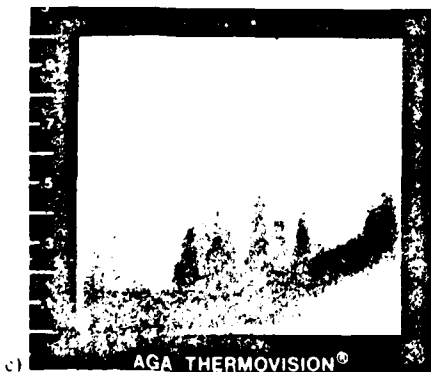
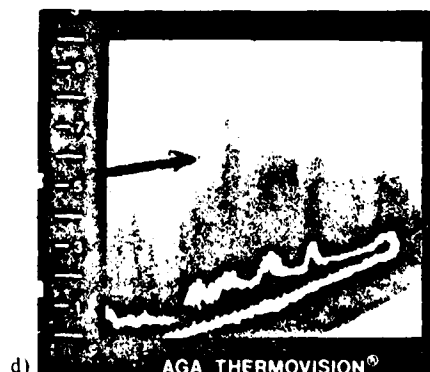
- a) Construction of outside wall with interior and exterior metal siding.
- b) Bad sealing at floor angle and insufficient filling of insulation material in wall.
- c) Thermogram of surface portion at floor angle where interior metal siding meets concrete slab. Cooling caused by inward air leakage through joint between floor joist and slab. Air also propagates upward in the wall between plate and insulation material.
- d) $t_{ref} = + 11^{\circ}\text{C}$
 $\Delta I = + 1.9$ isotherm units
 $\Delta t = 4.0^{\circ}\text{C}$
 $v = 0.5 - 2.0$ m/s (at siding connection with concrete slab).

COMPARISON THERMOGRAM - INDUSTRIAL BUILDINGS - OUTSIDE WALLS
WITH STEEL PROFILES (interior and exterior metal siding).

FIGURE 88: Deficiencies in insulation and tightness due to locally eliminated wind barrier and bad filling of insulation material in the wall.
